SERVICE BULLETIN NO. MSB1078-163/1

1.4 Subject:

ATA-Code: 20-10 Standard Practices - Airframe
 57-10 Wing Structure

G 115C/D/E/EG

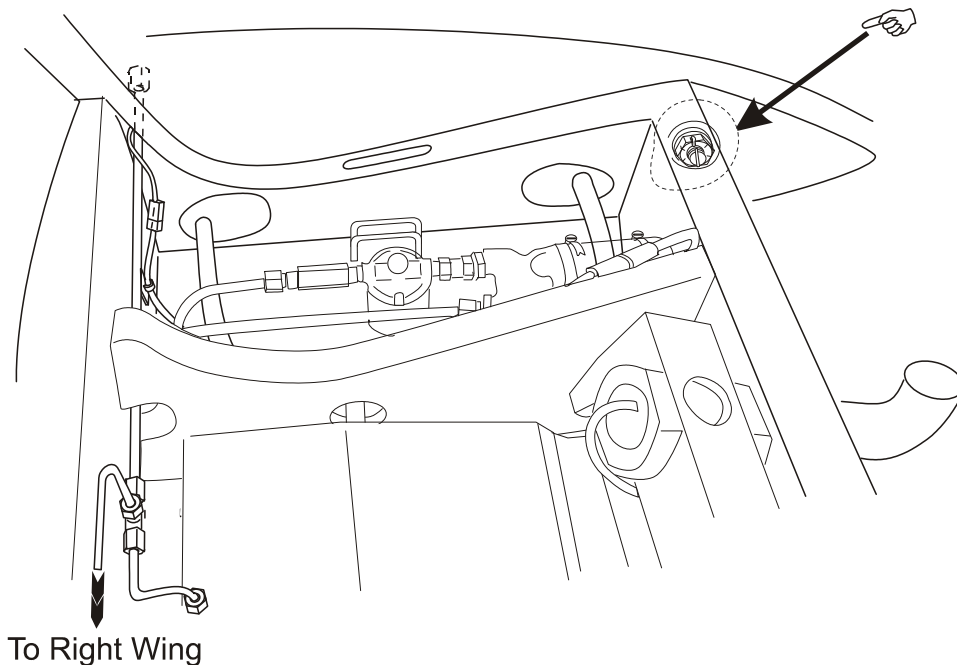
Fig. 2

- 1.8.3. Release the cockpit trim panel in front of the pilots seat to get access to the RH and LH front wing shear bolts I.A.W. MM chapter 25-10 (Fig. 2).

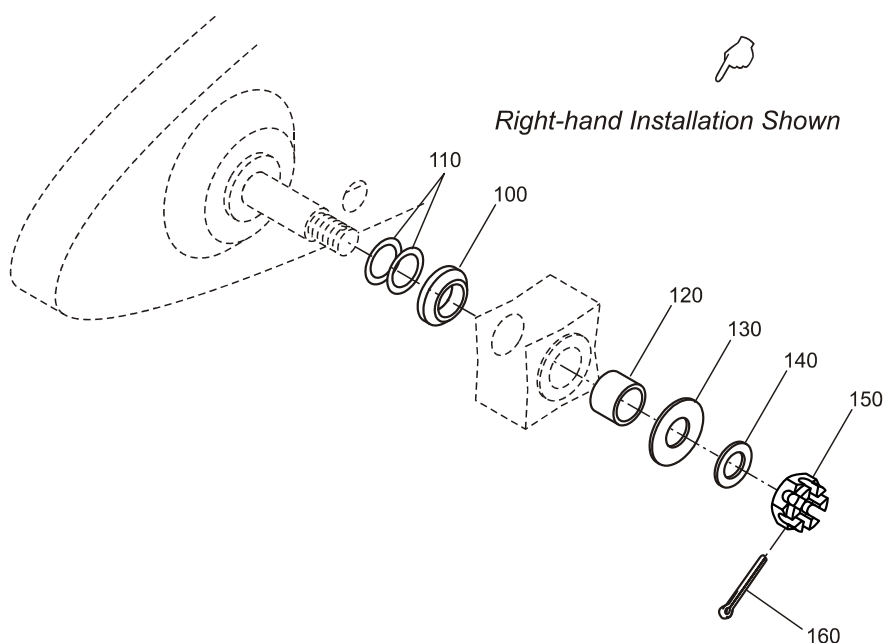
Fig. 3

During final assembly of a new series production aircraft it was revealed, that the corresponding Maintenance Manuals give different and incorrect torque values for the wing shear force fitting nuts, although the approved design data give the correct value.

- 1.8.4. Remove cotter pin LN94-4x30 (Fig. 3, item 160) from each wing shear bolt.
- 1.8.5. Release castellated nut P/N LN9345-M16x1,5 (Fig. 3, item 150) as follows:

- turn open both nuts at the LH a half turn
- if washers underneath are turnable, the shimming between wing and fuselage is correct and you may proceed with para. 1.8.6
- if washers underneath is not turnable, proceed as follows:
 - release castellated nuts further stepwise by 1/3 turns until washer is turnable. Note number of 1/3 turns to determine required additional shims (1 whole turn = 1.5mm, thread pitch)
 - remove LH wing I.A.W. MM chapter 57-10
 - install additional shims P/N 115C-1001.28 (Fig. 3, item 110, thickness 0.5mm) between wing and fuselage as required
 - install wing I.A.W. MM chapter 57-10, torque each castellated nut with 20 - 50 Nm (14.75 – 36.87 lbf.ft), note para. 1.9

1.8.7. Torque each castellated nut with 20 - 50 Nm (14.75 – 36.87 lbf.ft).

1.8.8. Install cotter pin LN94-4x30 to each wing shear bolt. If the cotter pin can not be installed within the torque range specified in 1.8.7 use shims P/N DIN 988- 24x17x thickness as required to be placed between the two washers (item 130 and 140).
