## SERVICE BULLETIN NO. MSB1078-164

ATA-Code:	52-10 Canopy – Canopy Jettison
-----------	-----------------------------------

G 115C/D/E

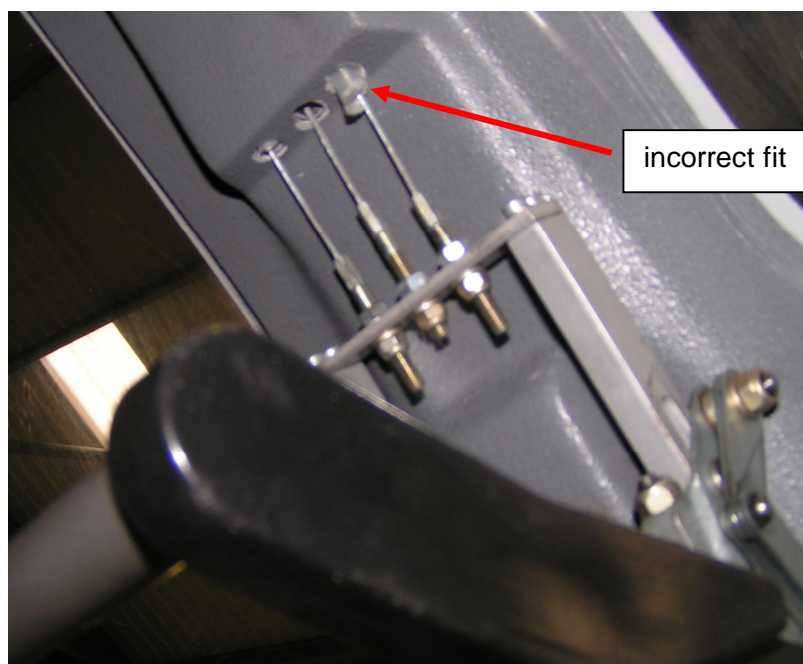
Fig. 1

Grob received an occurrence report of a failed canopy jettison test, experienced during a regular maintenance check. The investigation revealed, that a cable shroud of the jettison system protruded the canopy structure, which probably caused the malfunction (see Fig. 1).

- ensure that all jettison pins are withdrawn before the canopy handle contacts the rear handle cover
- check that the LH and RH handle protection covers do not contact the rear handle cover
- remove the rear handle cover and inspect the area where the jettison cables enter the canopy structure (see Fig. 1) for evidence of the cable outer shroud becoming detached from the canopy structure
- check canopy handle for excessive wear in the mechanism

1.8.3. If the jettison fails a repair according to a repair instruction provided by Grob must be performed and/ or the canopy handle must be replaced I.A.W. MM chapter 52-10.
